Manhole Inspection Summary

Manhole # S23KK1020MH

Insp Date: **11/20/06 10:45 AM**

Location Address: **4410 GRAND VIEW AVE**

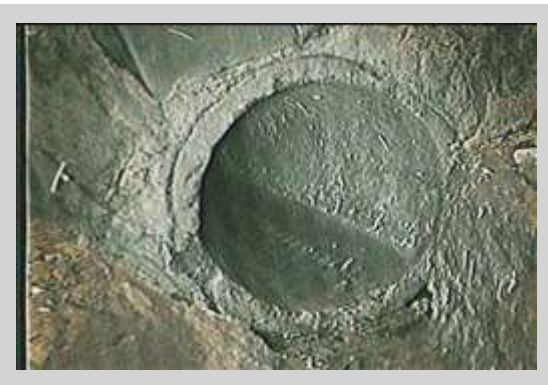
6 in. Circular Gravity Sewer Pipe In @ 3 O'Clock

Pipe Material: **Clay** ☐ Pipe Lined

Invert Depth: **7.30** (ft.) Flow Characteristics: **Slow**

Infiltration: **None** Pipe Seal Cond: **Unknown**

Connects To: **House connection / Service line**

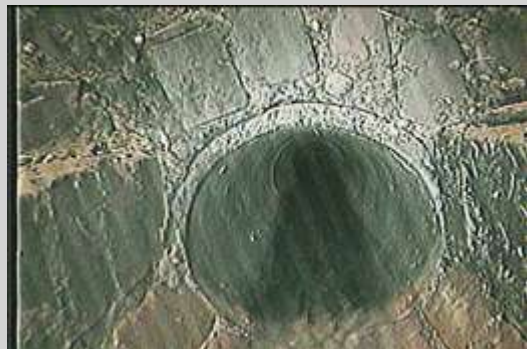
8 in. Circular Gravity Sewer

Pipe Material: **Clay**

Infiltration: **None**
